MAINTENANCE INSTRUCTIONS

CHECK VALVE WITH LID MODEL "EREZ" NR-040, NR-042, NR-044

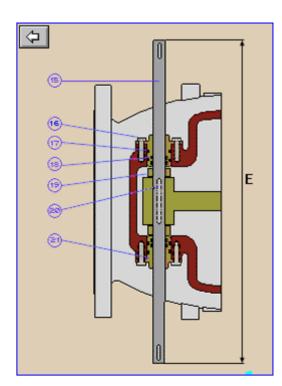
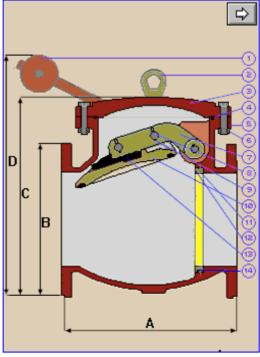
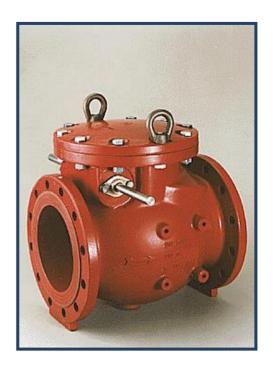
- □ The valve can be installed either horizontally or vertically, while the flow is toward the upper part.
- □ The **counter weight assembly** (1) will be installed so the arm turns down at a 45⁰ angle when the valve closes.
- □ **Shut-off valve** in order to allow maintenance and removal of the valve, a shut-off valve will be installed before the inlet and / or after the outlet of the valve, according to the conditions in the pipeline.
- □ It is recommended drainage valves before and after the valve in order to release the pressure and to drain the line.
- □ **Stainless Steel Shaft** (15) it is forbidden to weld or to coat the shaft.
